# Preliminary Science Flight Report

## Operation IceBridge Antarctica 2011

**Flight:** GV-FL01  
**Mission:** LVIS-Thwaites01

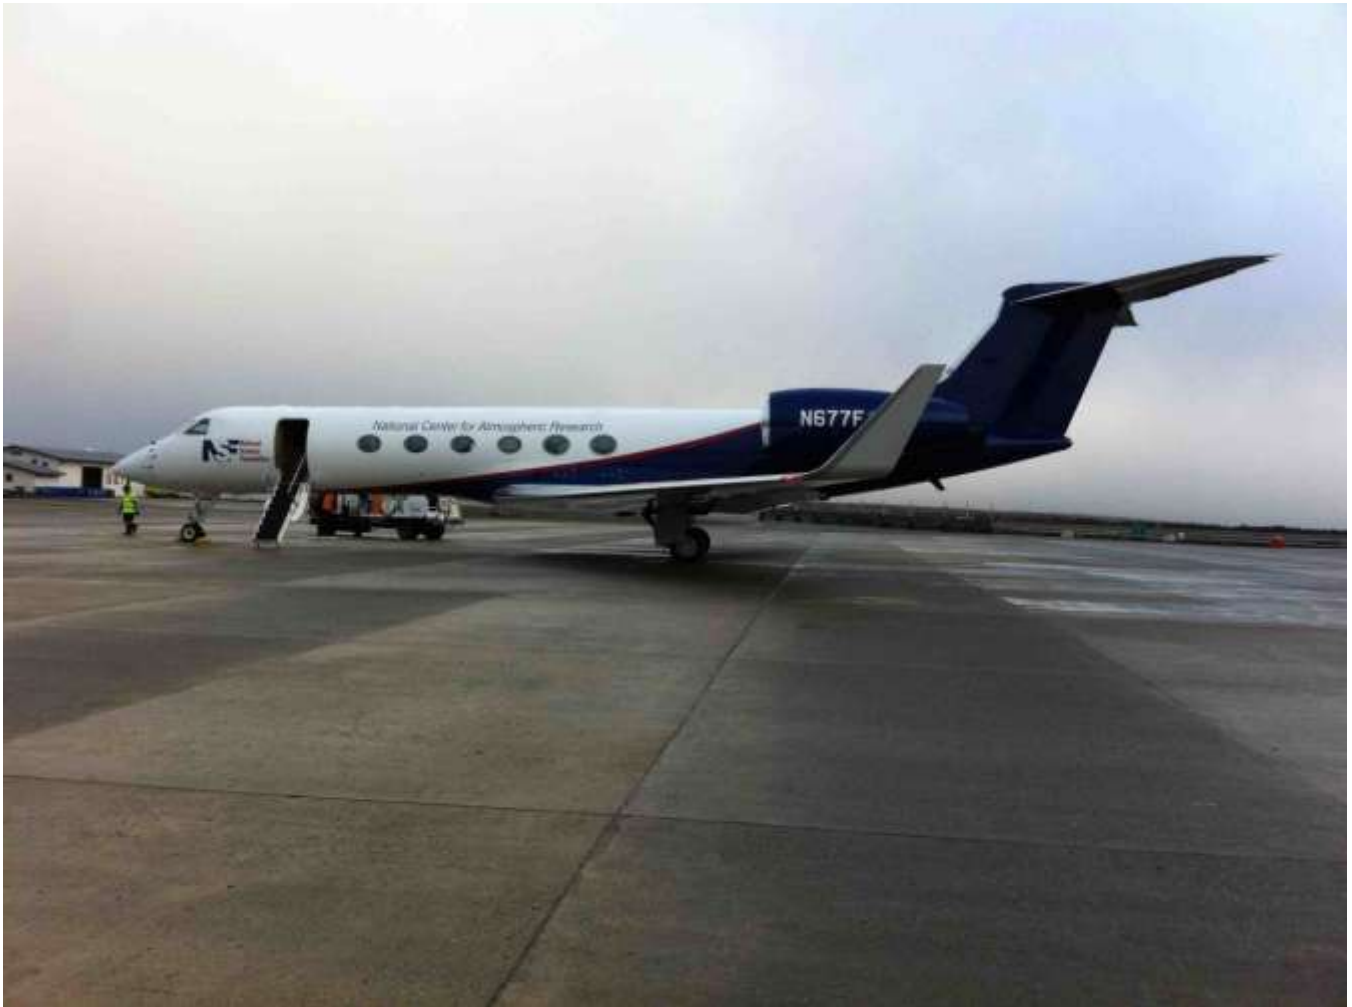
NSF/NCAR G-V (Gulfstream 5) aircraft with LVIS sensor onboard on the Punta Arenas airport ramp.  
(Photo credit: Michelle Hofton)
